ACTIVITY REPORT - MOUNTAIN PASS MINE

Dr. Erik Melchiorre, Geology Department, California State University San Bernardino, 5500 University Parkway, San Bernardino, CA 92407

Year 1: reconnaissance, mapping, and structural data collection

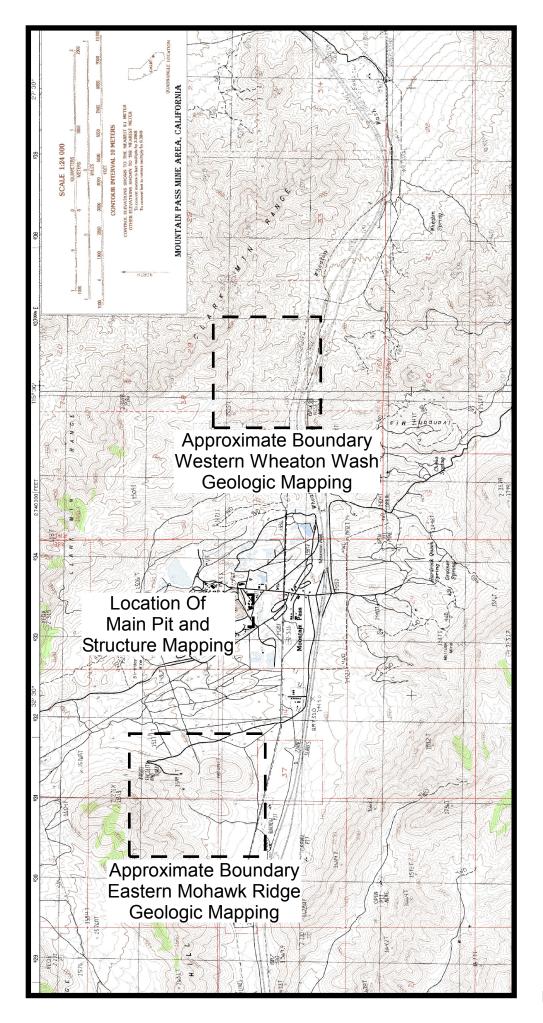
Figure 1

We have produced maps and detailed structural data for three areas of interest around the mine site. These include Eastern Mohawk Ridge, The main Open Pit, and a portion of Wheaton Wash (Figure 1).

The "North Fault," a significant structure, lies within the area of Wheaton Wash that was mapped (Figures 1 and 3). Bedrock consists of undifferentiated gneiss and coarse-grained sillimanite gneiss. Juxtaposed gneiss units, abrupt changes in foliation, and a breccia unit which crops out is several places delineate the trace of the North Fault. The nature of the breccia unit must be further examined, as in places this unit appears to contain fragments of pyroclastic material. Apparent offset of an andesite dike suggests a minimum right-lateral strike-slip displacement of 650 feet along the North Fault. The south-eastern terminus of the fault is poorly defined and additional work may be required if this sector is determined to be of importance.

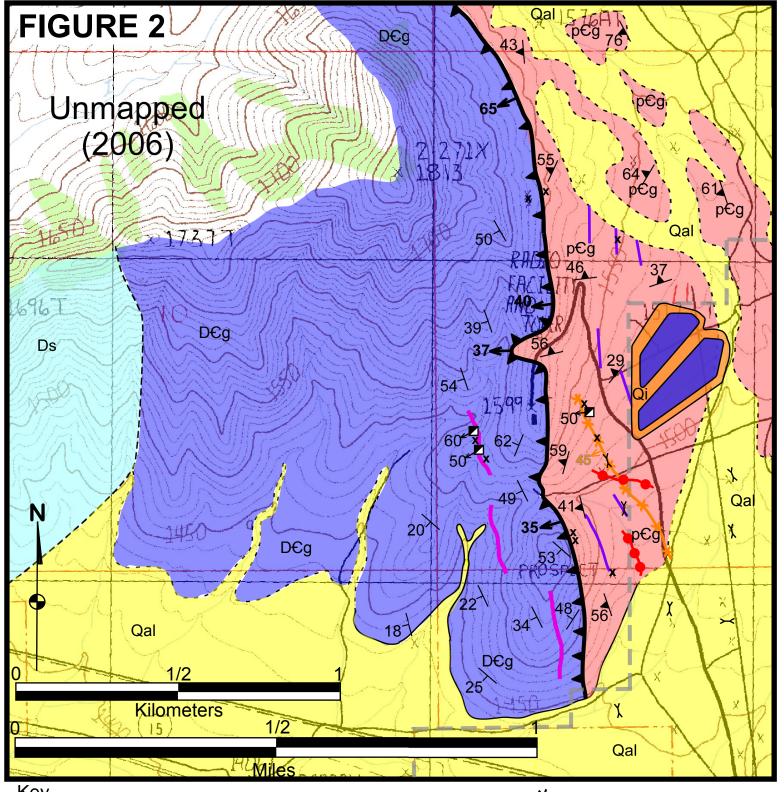
In the Eastern Mohawk Ridge area, a significant structural boundary was mapped (Figure 2). This thrust fault contains ample evidence of pale-fluid flow (e.g., sulfide mineralization as chalcopyrite, galena, sphalerite). However this period of fluid flow involved high temperature, reducing fluids, and most likely occurred during the main period of (Tertiary?) sulfide mineralization associated with emplacement of other local sulfide deposits such as the Sulfide Queen and Mohawk ore bodies.

Evidence of later, lower temperature fluid flow, is located exclusively within a zone of kaolinized fault breccia and gouge 1-4 feet thick and centered upon the thrust fault. Well-formed secondary calcite and gypsum crystals are observed to have grown in some portions of the fault gauge. This fault appears to presently serve as a conduit for minimal and highly localized meteoric fluid flow within portions of the fault itself, mainly as interconnected pockets and fractures which could best be modeled as fracture flow. The very elevated clay content of the gouge and breccia probably serve as a barrier to significant cross-fault fluid flow. In addition, the limited flow across the fault or leaking from the fault, itself has

placed calcite-saturated fluids from the carbonate unit to the west into the fracture flow Thus, while the fault may be a conduit for limited flow within the fault itself, it most likely serves as an effective barrier to fluid flow to the west.

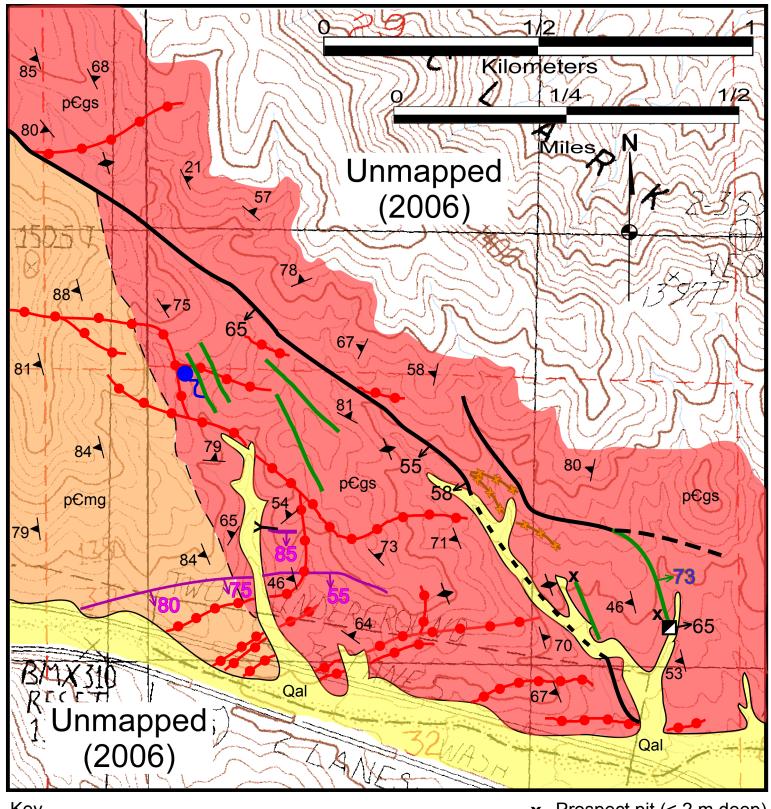
FIGURE 3

Fluid flow along the North Fault structure is not sufficient to produce springs, seeps, or vegetation anomalies.

One spring with a maximum observed flow rate of 5 liters/minute (March 2006) was observed to emerge at the base of a highly competent andesite dike. This spring is seasonal and flow completely stopped by August 2006. The field relations and observations suggest a shallow, fracture flow dominated spring system. Stable isotope and geochemical samples were obtained and are preserved by acidification and refrigeration for future analysis.

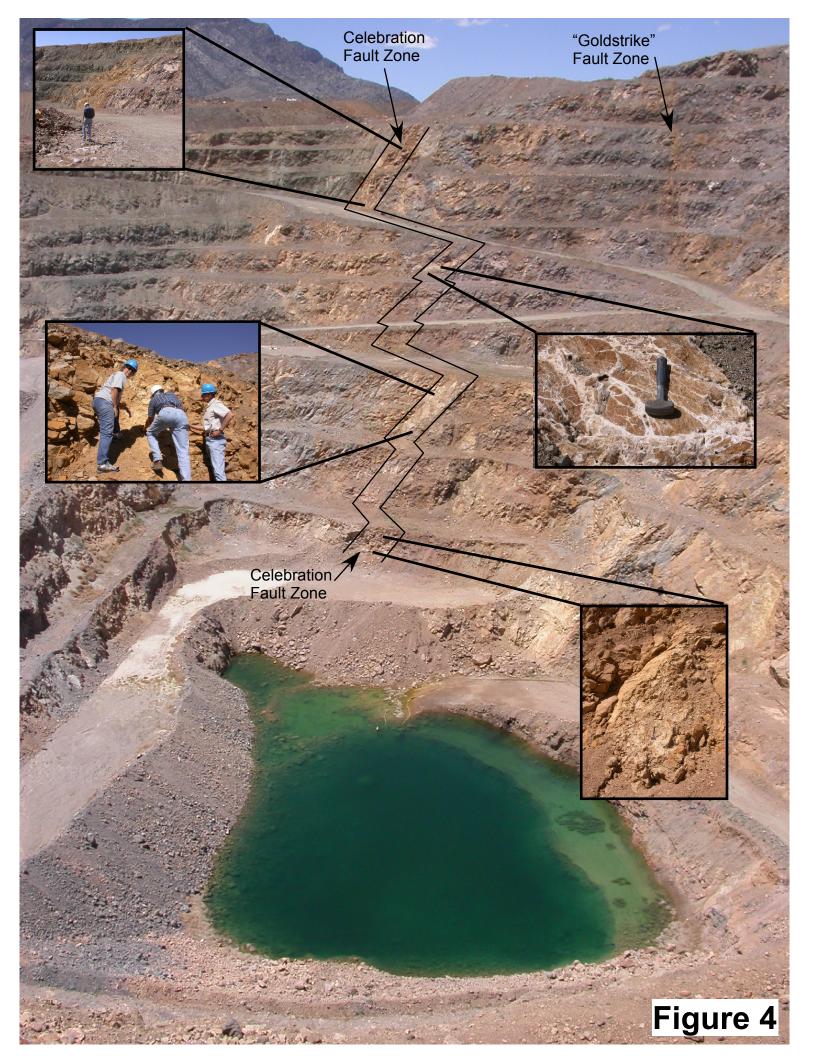
Detailed observations were made of the Celebration Fault Zone within the main open pit of the Mountain Pass Mine (Figures 4, 5, and 6). The location of this fault and the general character of the exposure is shown in Figure 4.

The upper portions of the fault are almost completely cemented by a white "calcite." This calcite is banded at the 1-cm to 10-micron level and contains inclusions and bands of other minerals, and will be examined in detail in next years work. Not only are fractures filled with this "calcite;" brecciated zones are completely cemented by this material (Figure 4). The "calcite" does not exist in any significant quantity below the 4500 level of the mine, with the most pervasive mineralization occurring between the 4700 and 4600 levels. This "cap" of secondary mineralization serves as a low permeability barrier to downward fluid flow and local meteoric recharge, except where disrupted by mining activities. Recharge of the more permeable lower portions of the Celebration Fault through this well-cemented upper zone should very limited, and only then, through very discrete zones where porosity is fortuitously linked. The lower portions of the fault below 4500 level are highly fractured, and mine personnel report that this structure "makes significant water" in the deepest levels of the mine.

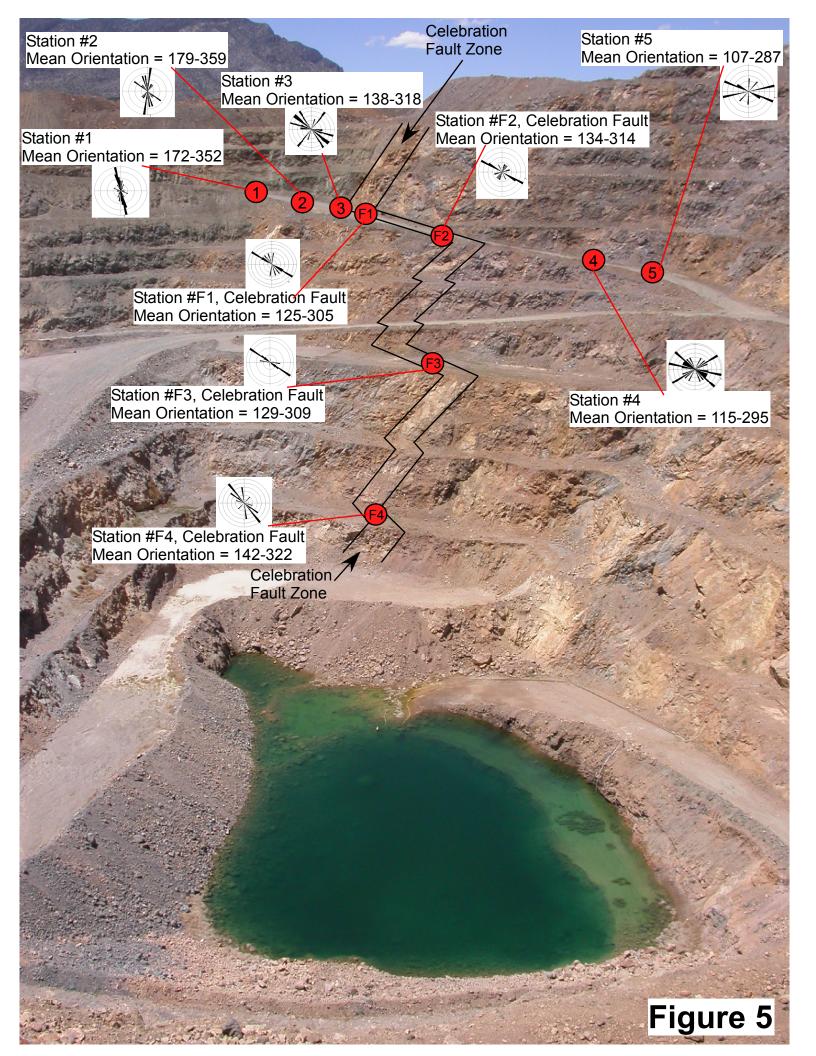
The orientation of fractures to the west of the Celebration Fault (Figure 5, view is approximately to the north) is roughly N-S. Within the fault zone the fractures are oriented roughly NW-SE. East of the fault the fractures have a bimodal orientation preference, probably due to the position of this block between the Celebration Fault and the Goldstrike Fault (Figure 4). Station 3, located 10 feet from the fault, was the only station west of the fault to show fracture orientations that are similar to the fault itself.

Fracture densities are quite low (5.5 to 10.9 m/m²) adjoining the fault, but quite elevated (18.3 to 41.1 m/m²) within the fault itself. The apparent increase in fracture density with depth results from the healing of multiple individual fractures into single recognizable zones by the "calcite" within the upper portions of the fault. The drop in fracture density between station 3 and station F1 (15 feet apart) is quite marked and abrupt.
